Special Report 87-16

Evaluation of the Shasta waterless system as a remote site sanitation facility

C. James Martel

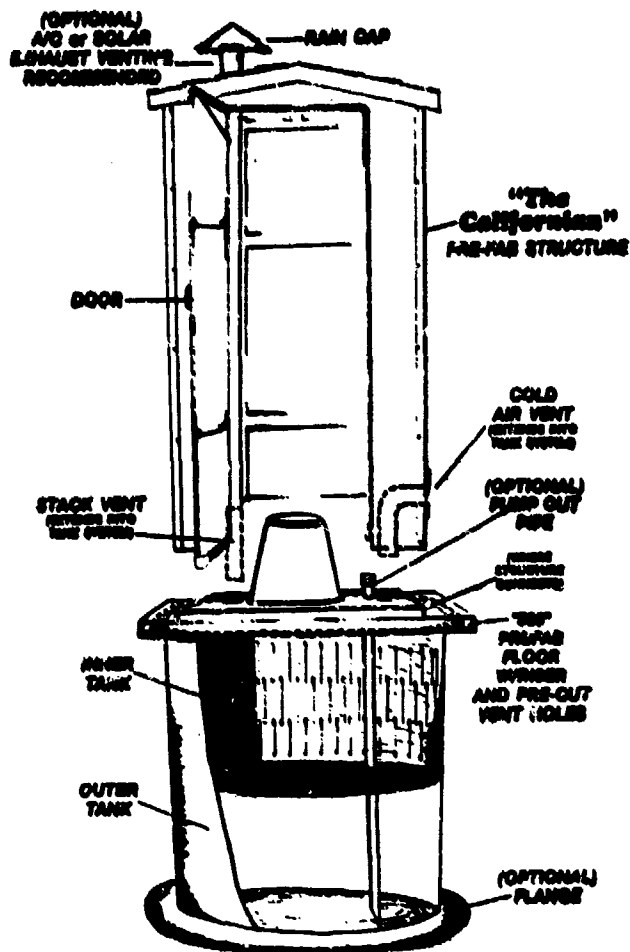
Figure 2. Configuration of assembled components.

Both tank and basket are installed in the ground with the toilet building placed on top (see Fig. 2). For proper installation care should be taken to seal around the toilet building in order to prevent surface runoff from entering the holding tank. The "Californian" pre-fabricated structure made by Shasta has a specially designed floor that forms a tight seal around the tank. Also, care must be taken when backfilling around the tank to avoid deformation. A deformed tank can restrict airflow around the basket and interfere with basket removal.

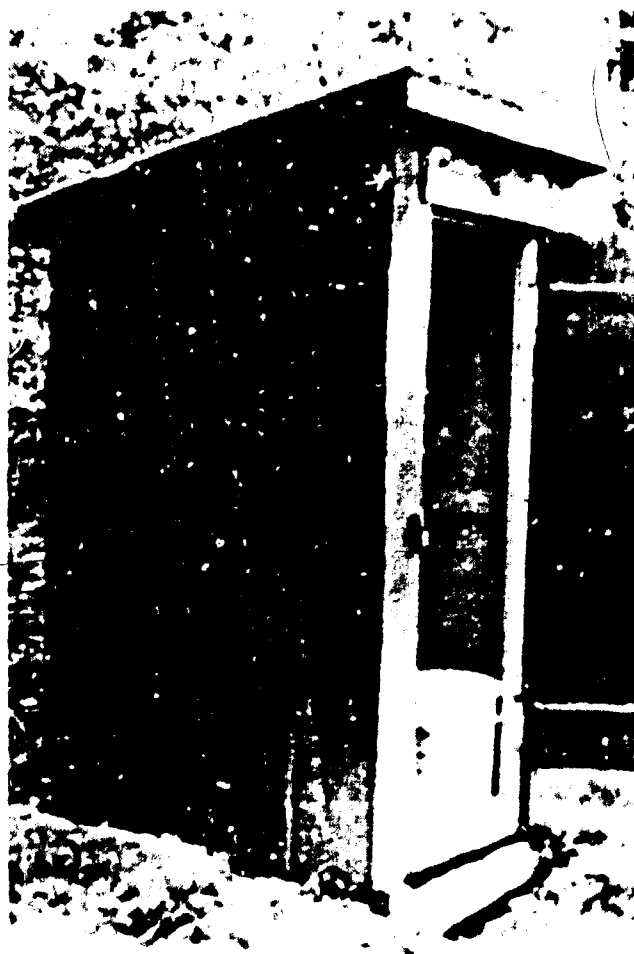
Figure 3. Shasta unit at Shenandoah National Park, Virginia.

On 19 July 1984 I met with Donald Jenkins and Mary Ellis of the National Park Service. We visited a 250-gal. Shasta unit located near Bearfence Mountain. This unit was installed in 1982 to replace a pit toilet, which had been difficult to relocate in the rocky terrain. The toilet building used with the pit was placed over the Shasta tank and basket. Although the building was structurally sound, it did not appear to be properly sealed around the base to prevent surface runoff from entering the holding tank nor was it vented properly. To prevent the tank from flooding, a drain pipe was installed just below the basket level. This drain pipe daylighted to a wooded area about 25 ft downslope. The end

of the drain pipe was screened to prevent animal intrusion. The ground beneath the end of the drain pipe was wet, indicating that either condensation or liquid discharge from the tank had occurred. Figure 3 is a photograph of the unit.

During my visit I noticed only a slight odor in the vicinity of the unit. A bucket of lime was provided as an aid for odor control. Mr. Jenkins stated that he had no problems with this unit during two full years of operation.

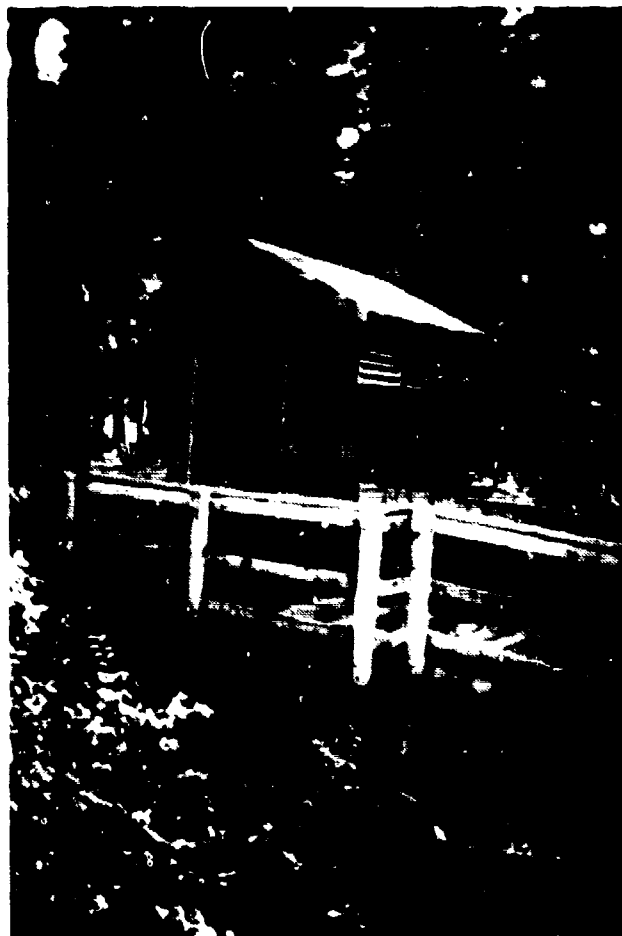
Figure 4. Shasta unit at Tongass National Forest, Alaska.

On 11 October 1985 I visited a 500-gal. Shasta unit near the shores of Lake Eva, 25 miles north of Sitka, Alaska. This unit was located about 100 ft from a log cabin that accommodates about 200 to 300 people per year during the summer months (130 days in 1984). A locally made wooden toilet building was placed over the Shasta unit (see Fig. 4). Although the build-

ing was well ventilated, there was little ventilation in the unit because no vent pipes went into the tank and basket. Consequently, the basket was about half full with moist solids, indicating that dehydration was not taking place. Despite this deficiency, only a slight odor could be noticed near the unit.

According to Thomas Keyes of the U.S. Forest Service, the unit filled with liquids after two seasons. It was emptied by first pumping water into the tank to resuspend the solids. The contents were then removed with a diaphragm pump and discharged and buried in a pit located behind the toilet building. Mr. Keyes concluded that some decomposition and evaporation had occurred but not enough to keep the vault from filling. Overall he was satisfied with the Shasta unit.

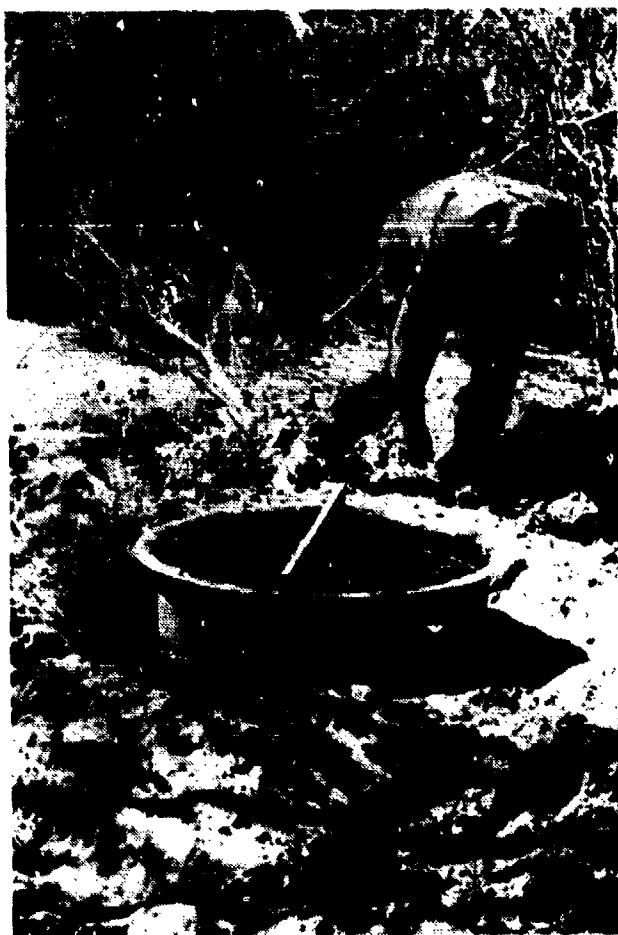
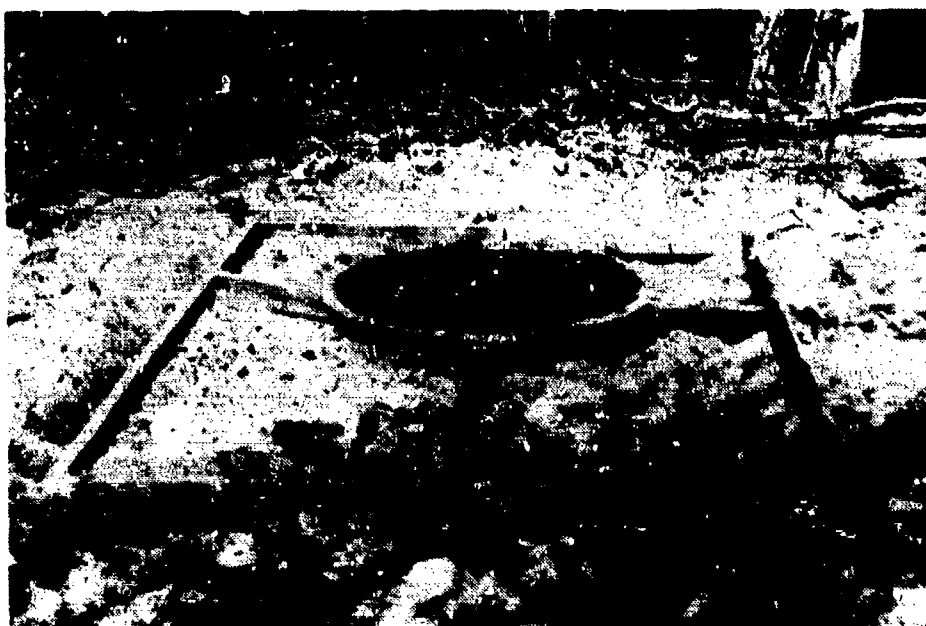
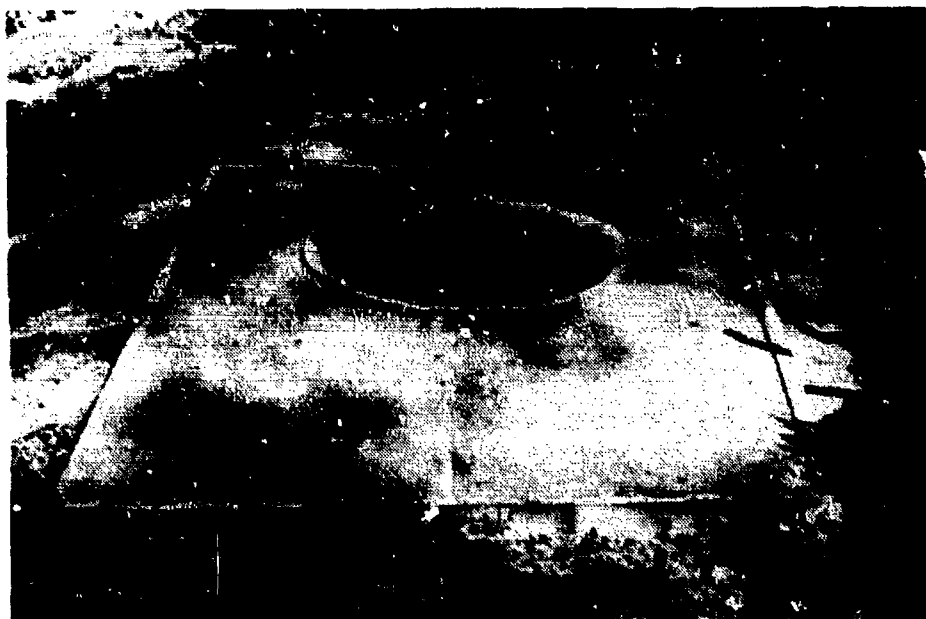
Figure 5. Installation of 250-gal. Shasta unit at Englebright Lake, California.

Located near Sacramento, California, Englebright Lake Recreation Area is operated by the U.S. Army Corps of Engineers. In March of 1986, I met with Douglas Grothe, Park Manager, who was in the process of installing 20, 250-gal. units and 10, 140-gal. units around the lake. He explained that the main reasons for selecting Shasta units were that they were lower in maintenance cost than the previously used chemical toilets, and they protected the groundwater which feeds into the lake. Figure 5 shows the installation of a 250-gal. holding tank.

a. Lowering tank into hand-dug hole.

b. Leveling tank.

c. Installing forms for concrete base.

d. Tank and base before installation of basket and toilet building.

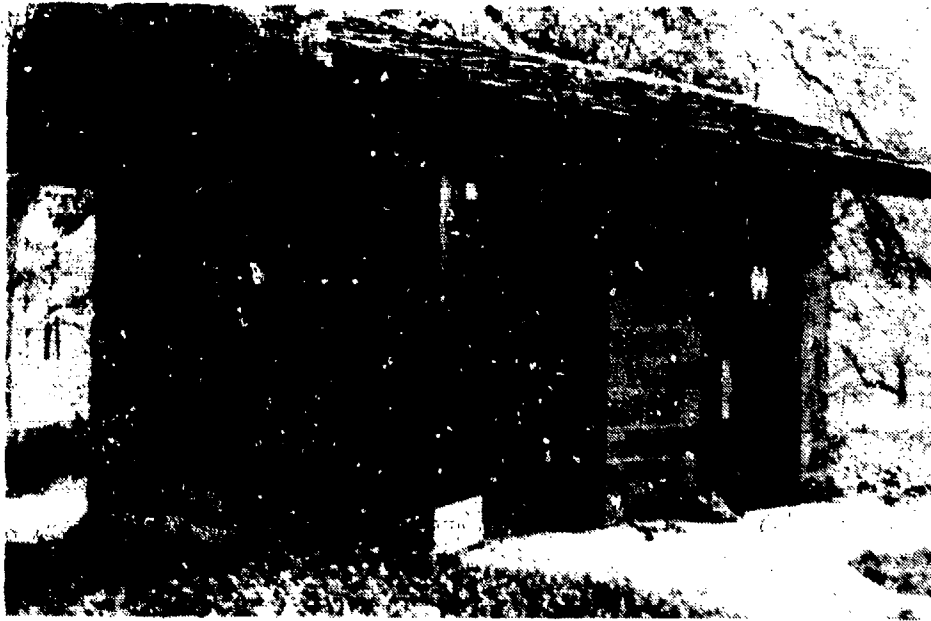
Figure 6. Selected Shasta units in California.

a. Ball's Ferry County Park.

b. French Gulch.

While in the northern California area, I visited Ball's Ferry County Park which had two 250-gal. units. Installed three years ago, these units had never been pumped out. Inspection of the units indicated that the solids in one of the baskets were saturated but little odor was evident. This particular installation did not have a protective rain cap on the stack vent. Moisture could have entered the basket via the vent during a large rainstorm that preceded my inspection.

I also visited a site (French Gulch) which had been in operation for five years. Again there were no odors and the solids in the basket did not appear to be saturated. These sites are shown in Figure 6.
